FALMOUTH VOLUNTEER FIREFIGHTER'S ASSOCIATION
FIRE AND EMERGENCY MEDICAL SERVICES
SAFETY BULLETIN

SUBJECT: TRUSSES WITHOUT GUSSET PLATES

NUMBER:
SB08-008

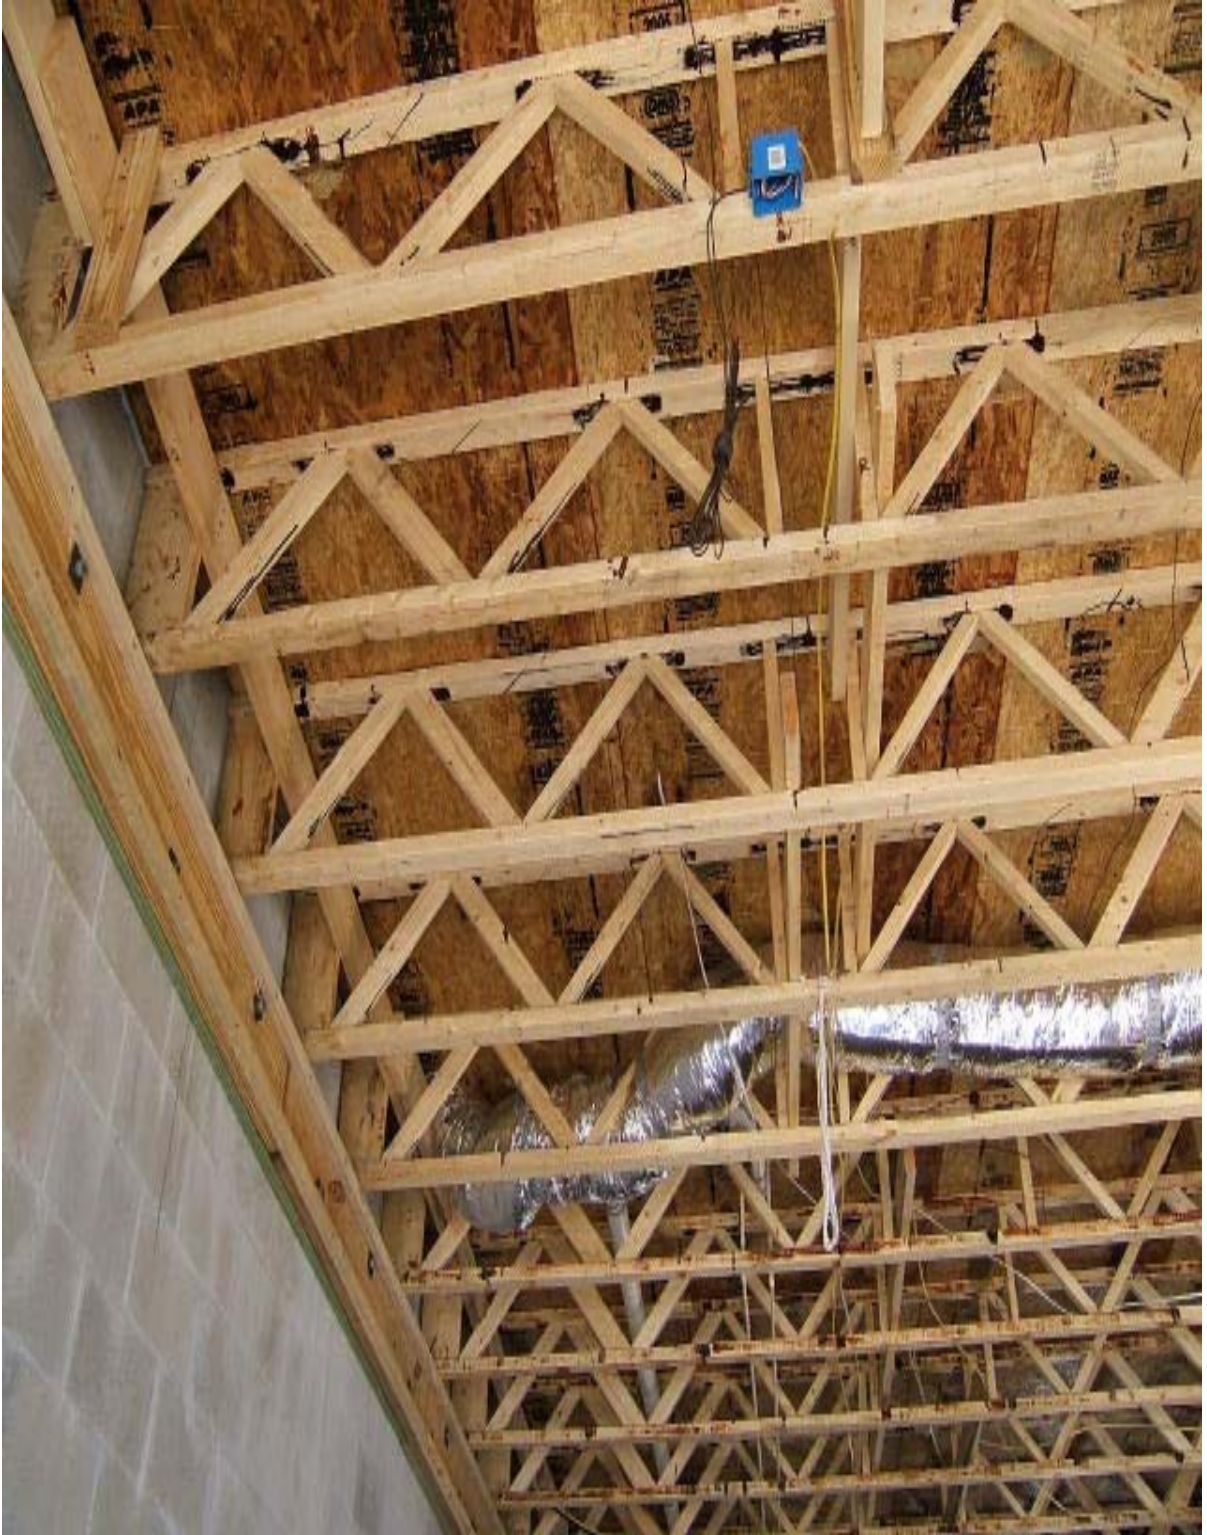
There are now wood trusses that are commercially engineered without gusset plates. This "new-breed" truss is simply a 2 X 4 that is *finger jointed and spot glued* where the webs meet the upper and lower chord members.

These trusses are being held up by a 2 X 8 or in some cases a "TJI" sill plate that is anchor bolted to the block sidewall. Look closely at some of the members; they do not appear to even be fastened but merely secured by the building's dead and live loads.

We have all been encountering a mixed variety of structural members, particularly plywood "I" beams (TJI) on upper floors with simple beams on joist-hangers (Teco Clips) on the lower floors. Now add these to the mix... Pre-fire planning for new construction in concert with early inspection holes in ceilings, for existing structures is becoming more and more critical.
